SINGLE SURVEY

A report on the condition of the property, with categories being rated from 1 to 3.

Selling address	24 St. Blanes Road Heathhall Dumfries DG1 3RH
------------------------	--

Prepared by	Simon Allen, Bsc MRICS Dumfries - Allied Surveyors Scotland Ltd
--------------------	--

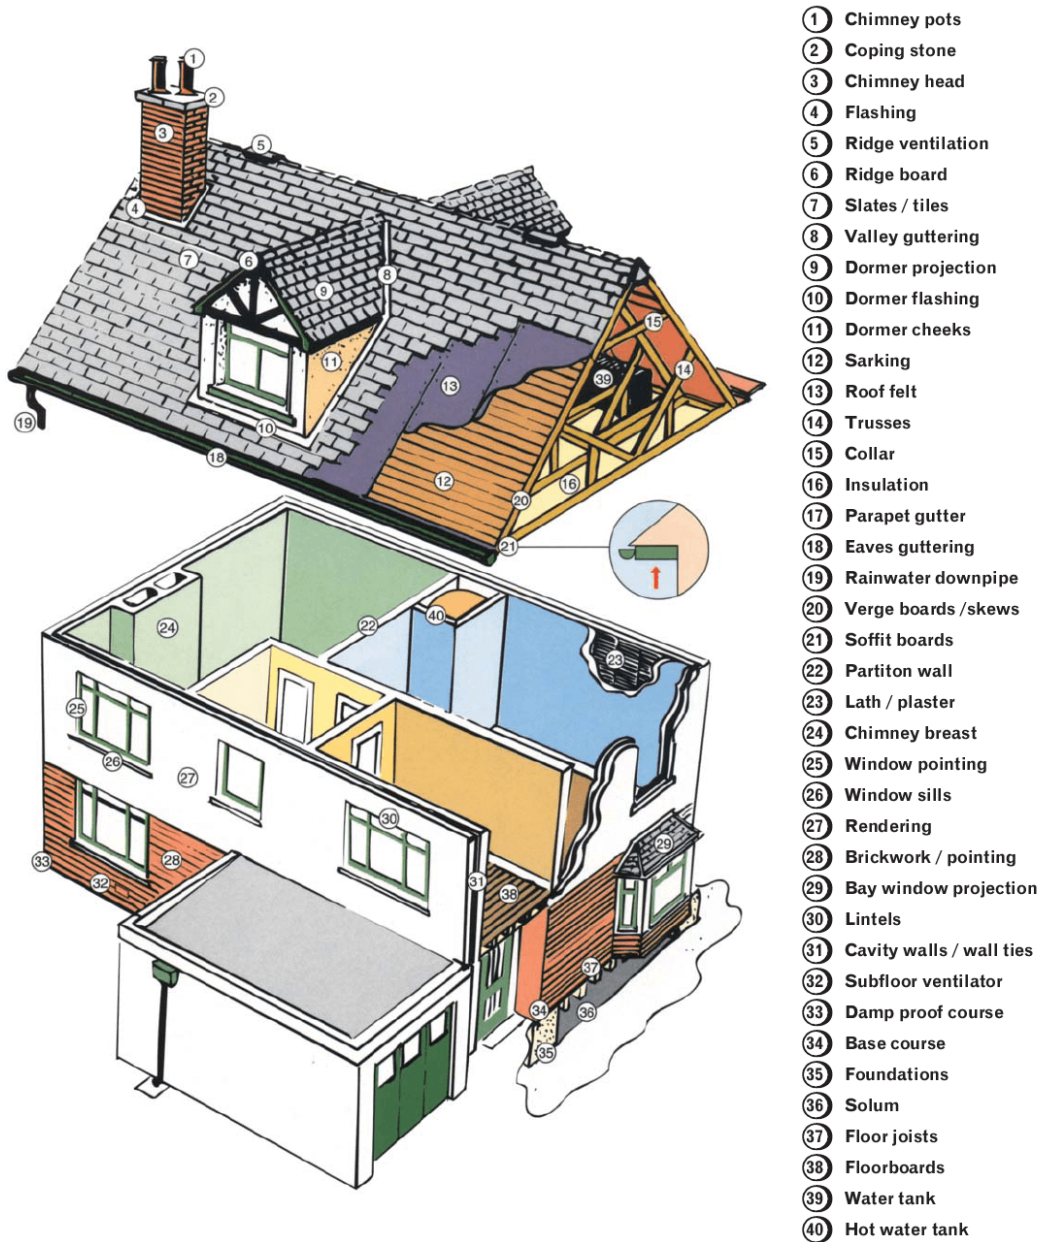
Sectional Diagram showing elements of a typical house

- ① Chimney pots
- ② Coping stone
- ③ Chimney head
- ④ Flashing
- ⑤ Ridge ventilation
- ⑥ Ridge board
- ⑦ Slates / tiles
- ⑧ Valley guttering
- ⑨ Dormer projection
- ⑩ Dormer flashing
- ⑪ Dormer cheeks
- ⑫ Sarking
- ⑬ Roof felt
- ⑭ Trusses
- ⑮ Collar
- ⑯ Insulation
- ⑰ Parapet gutter
- ⑱ Eaves guttering
- ⑲ Rainwater downpipe
- ⑳ Verge boards / skews
- ㉑ Soffit boards
- ㉒ Partiton wall
- ㉓ Lath / plaster
- ㉔ Chimney breast
- ㉕ Window pointing
- ㉖ Window sills
- ㉗ Rendering
- ㉘ Brickwork / pointing
- ㉙ Bay window projection
- ㉚ Lintels
- ㉛ Cavity walls / wall ties
- ㉜ Subfloor ventilator
- ㉝ Damp proof course
- ㉞ Base course
- ㉟ Foundations
- ㊱ Solum
- ㊲ Floor joists
- ㊳ Floorboards
- ㊴ Water tank
- ㊵ Hot water tank

Reference may be made in this report to some or all of the above component parts of the property. This diagram may assist you in locating and understanding these items.
