# YOUR ONESURVEY HOME REPORT

Primrose Hill  
15 Ashgrove Terrace  
Lockerbie  
DG11 2BQ

# Single Survey

# Mortgage Valuation Report

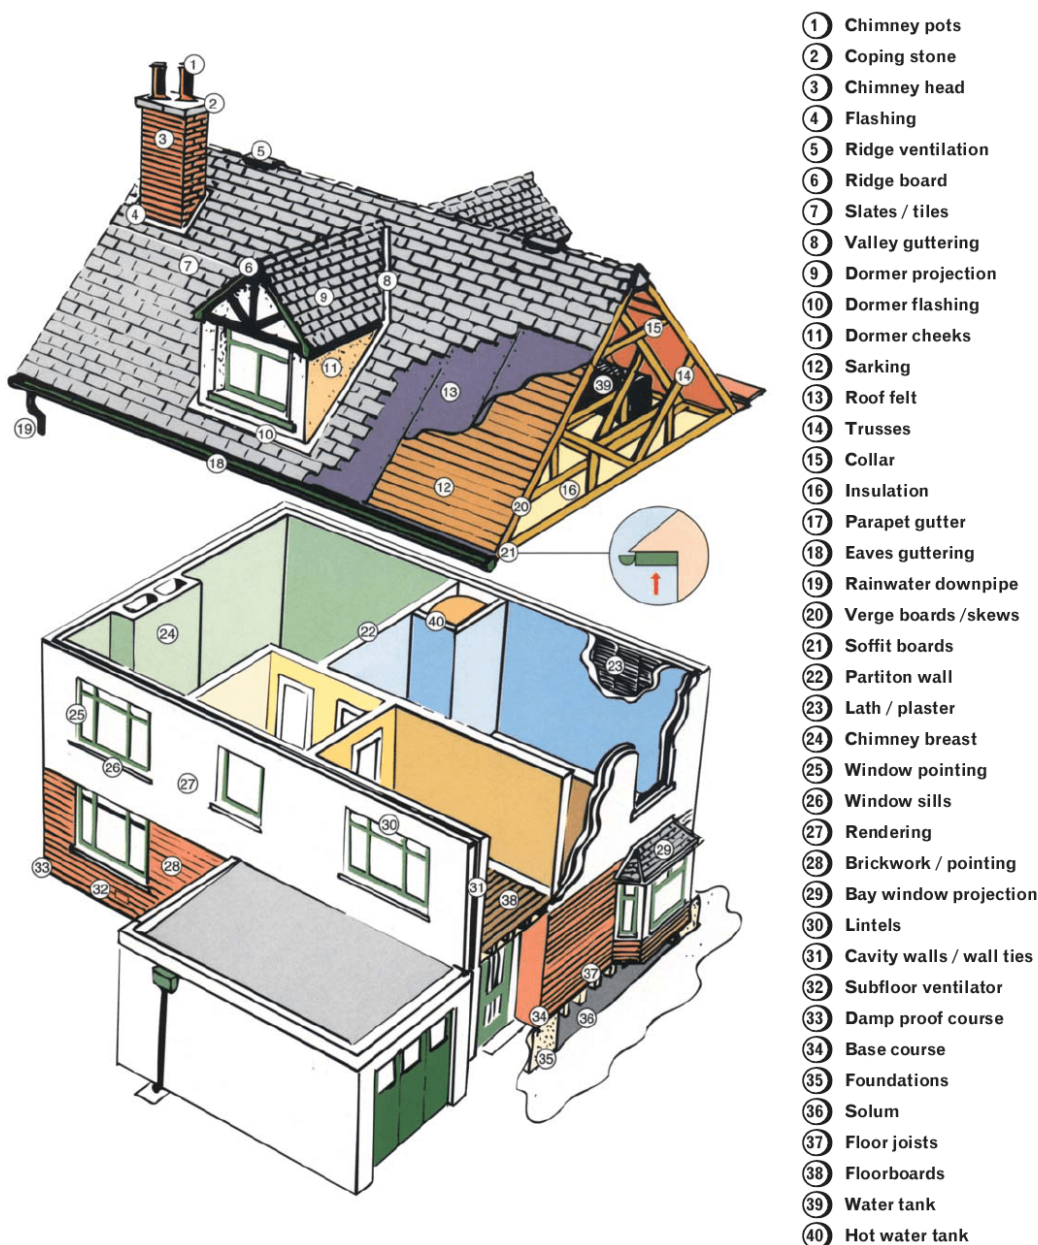
## Sectional Diagram showing elements of a typical house

Reference may be made in this report to some or all of the above component parts of the property. This diagram may assist you in locating and understanding these items.
