YOUR ONESURVEY
HOME REPORT

11 Alpine Terrace
Dalbeattie
DG5 4HJ

SINGLE SURVEY

A report on the condition of the property, with categories being rated from 1 to 3.

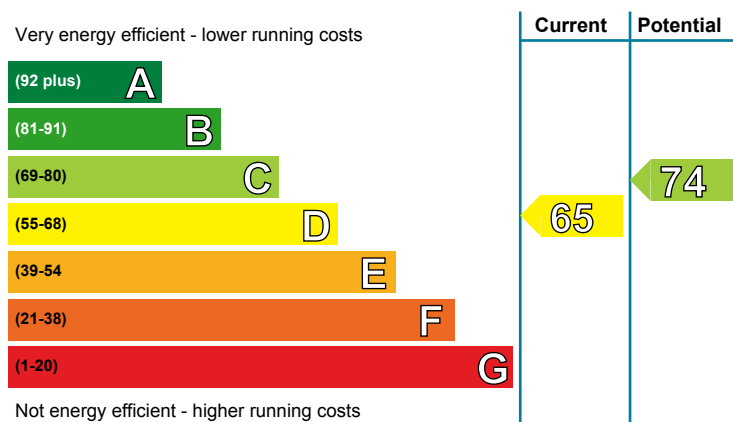
Energy Efficiency Rating

This graph shows the current efficiency of your home, taking into account both energy efficiency and fuel costs. The higher this rating, the lower your fuel bills are likely to be.

Your current rating is **band D (65)**. The average rating for EPCs in Scotland is **band D (61)**.

The potential rating shows the effect of undertaking all of the improvement measures listed within your recommendations report.

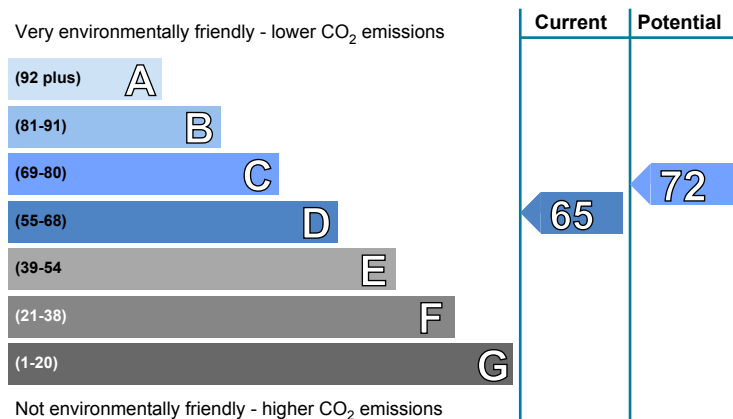
Environmental Impact (CO₂) Rating

This graph shows the effect of your home on the environment in terms of carbon dioxide (CO₂) emissions. The higher the rating, the less impact it has on the environment.
